Preliminary Geotechnical
Investigation Baldivis Substation
Sites 2 and 3

Client	Mr Rudy Williams
Project name	SDG 873 – Baldivis Substation
Document number	DMS# 6466958
Document title	Preliminary Geotechnical Investigation Baldivis Substation sites 2 and 3
Revision status	Rev 1

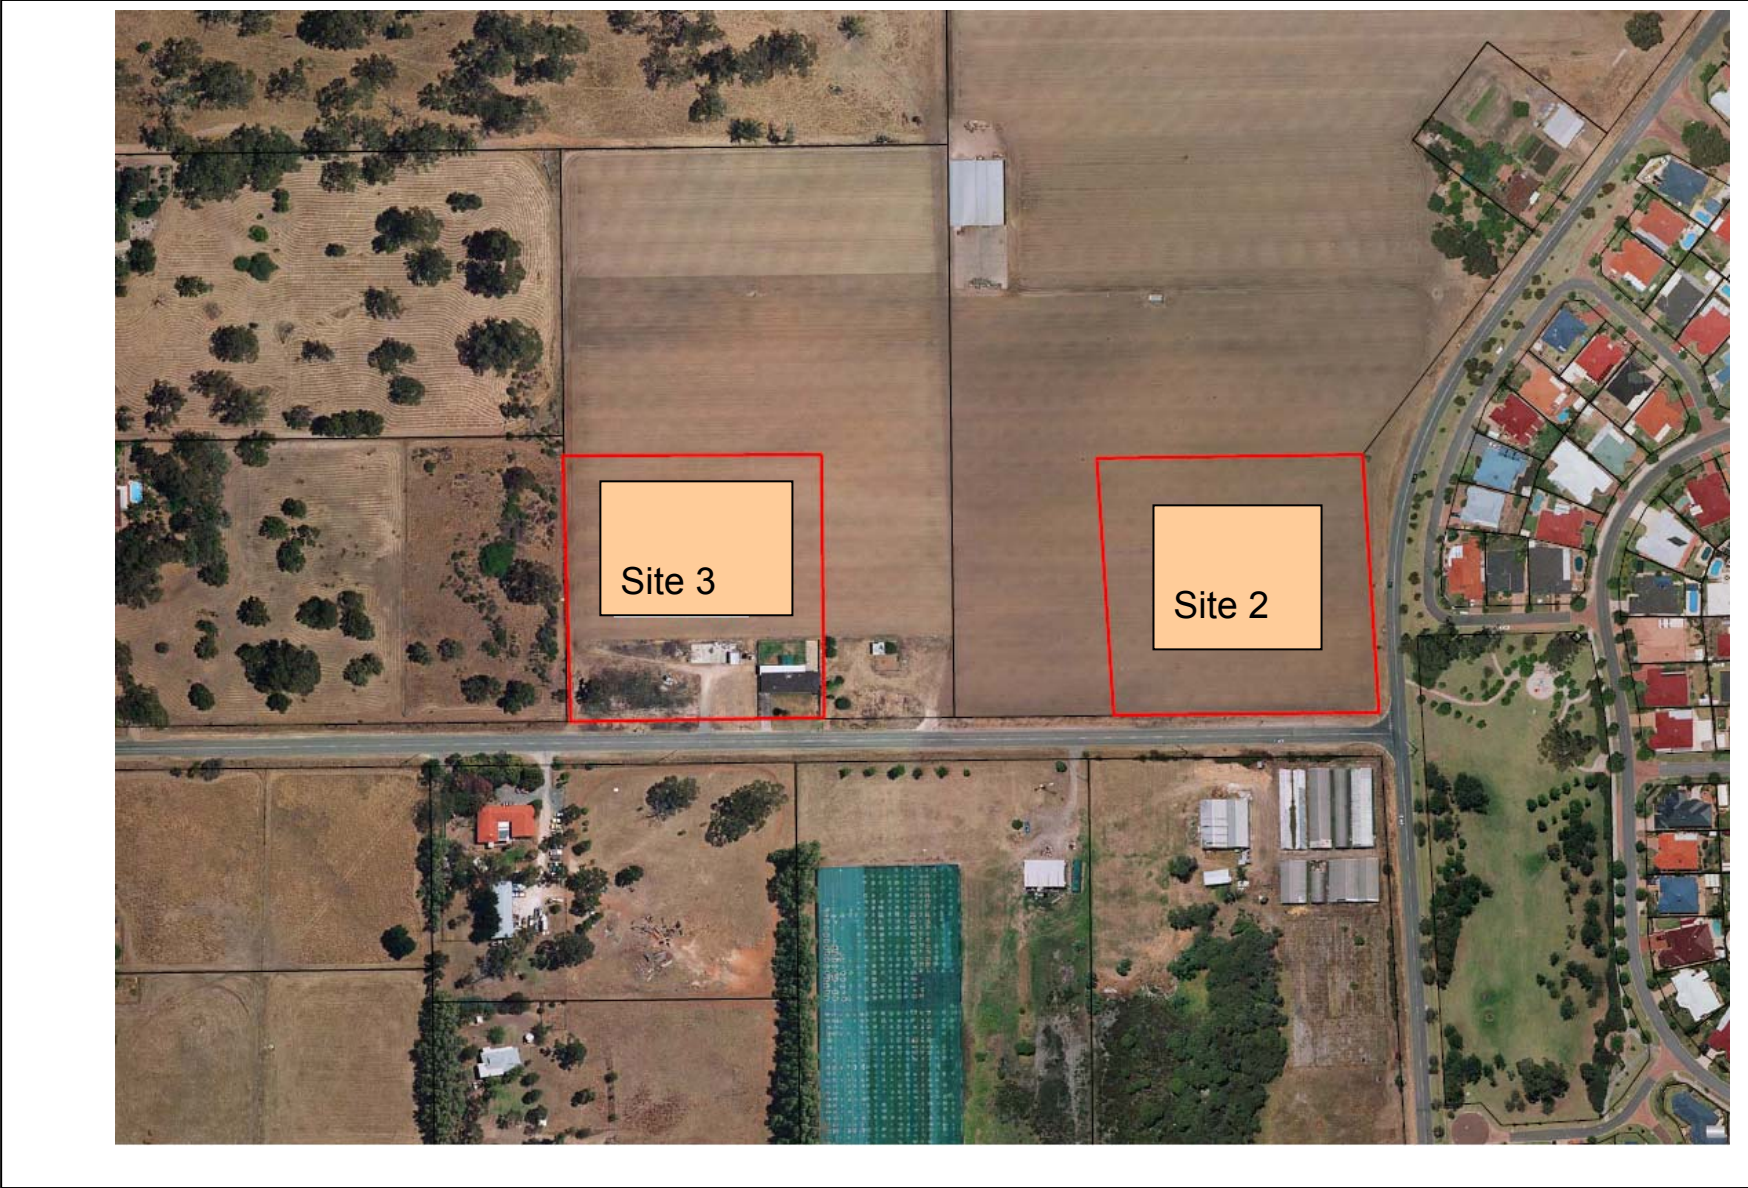
Appendix B - Site Plan

The current work was performed by CSES at the request of Mr. Rudy Williams of Western Power. The sites plan is shown in attachment B.

Details of Hand Auger Boreholes are provided in Table 1. The test locations were positioned based on information and plans provided to obtain a reasonable coverage of both sites.
