# Vegetation Clearing Desktop Report

T0547849 Mount Claremont

September 2025

Project Area		Contract/Work Order No: T0547849
<b>Project name:</b> T0547849 Mount Claremont Partial decommissioning of WT-N 72 line		
<b>Main purpose of clearing</b>  Clearing required for pole removal for the partial decommissioning of the WT-N 72 line. The pole has been deenergised.	Permanent/Temporary	Clearing area (ha)
	Permanent <input type="checkbox"/>	
<b>Proposed start date:</b> 21/10/2025	<b>Expected completion date:</b> 28/10/2025	
	<b>Method of clearing:</b> Mechanical and Manual	
<b>Machinery to be used:</b> Excavation, chainsaw, truck & chipper, bobcat, service vehicles.		
<b>Project details:</b> The project involves the removal of stay pole 19 within the decommissioned WT-N 72 line. The area requires the clearing of native vegetation to remove the steel pole and the concrete foundation.		
<b>Guardian Permit ID reference number:</b> PER-0001729	<b>Permit/Exemption number:</b> CPS1918/11

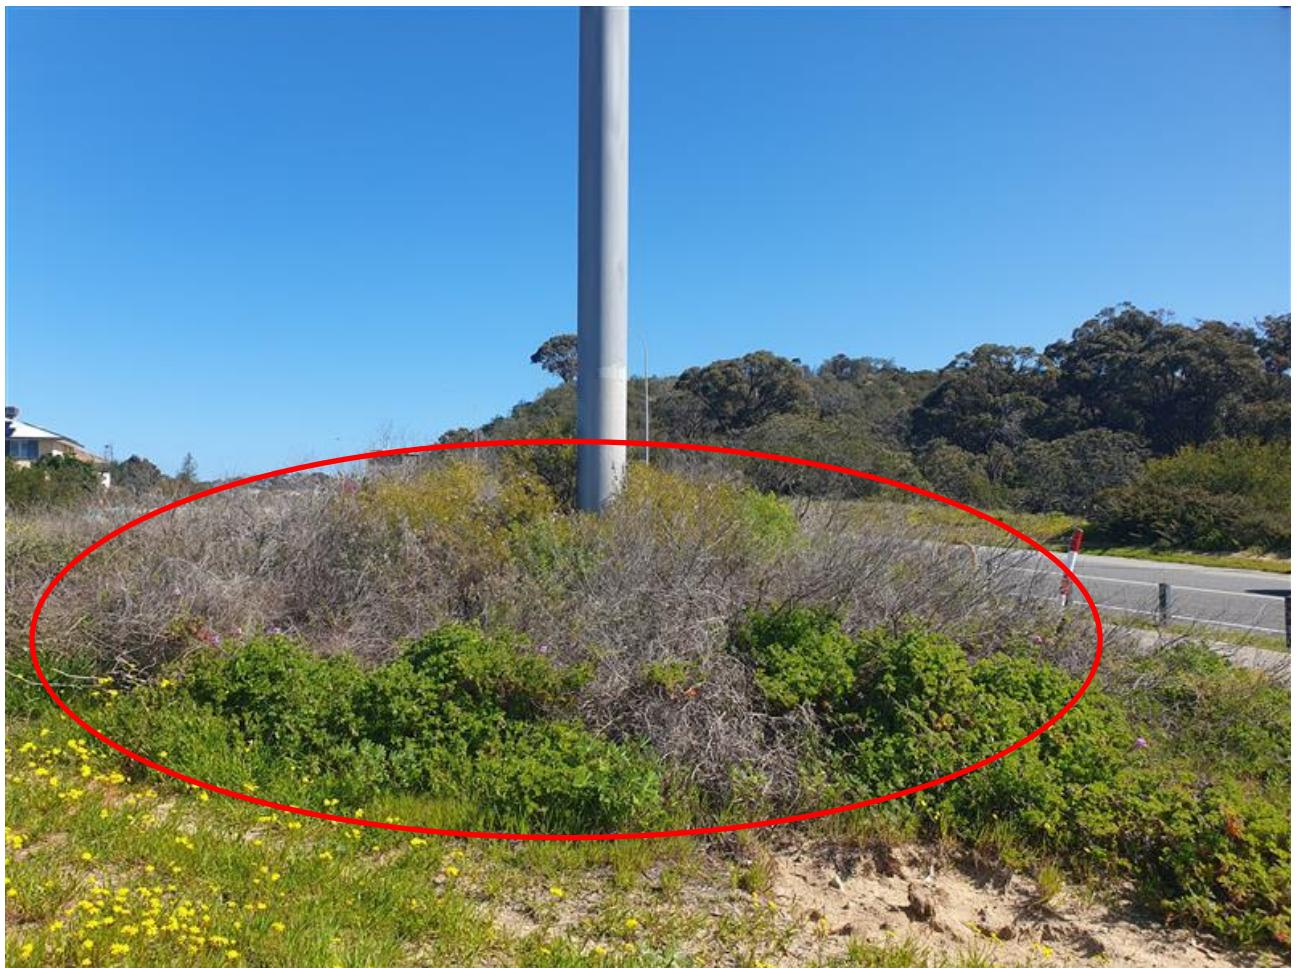
Image 3: Photo of degraded vegetation surrounding stay pole to be removed

The clearing involves the removal of ~ 0.03 ha of native vegetation. This includes a small area of shrubs within the road reserve of Stephenson Avenue, Mount Claremont. The area is in degraded (EPA, 2016) condition with a weed infested understorey. A desktop search showed the clearing area is located within a Priority 3 flora (*Stylidium maritimum*) buffer area however the occurrence of the flora species was recorded in 1987 and is within Bold Park Reserve. The *Stylidium maritimum* is unlikely to occur in the clearing area as it is outside Bold Park Reserve and has previously been cleared and developed as a road reserve. The *Stylidium maritimum* occurs in coastal heath shrubland and open Banksia woodland, the vegetation within the clearing area does not represent these vegetation communities as it comprises Geraldton Wax (*Chamelaucium uncinatum*) shrubs with a weed infested understorey.

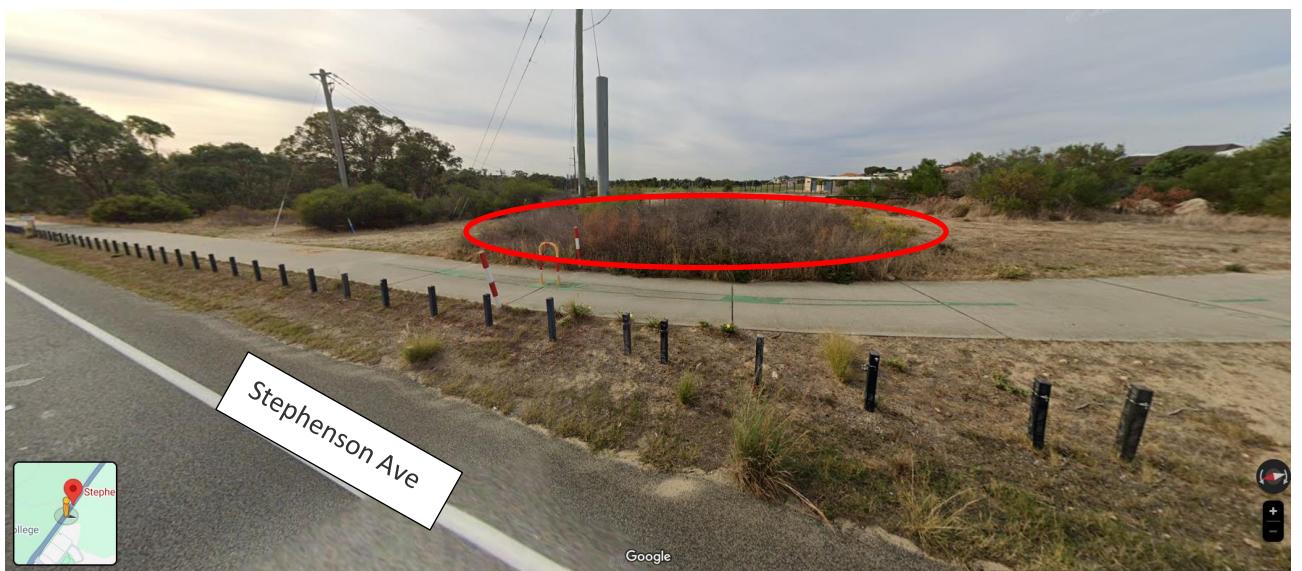
Image 4: Photo of degraded vegetation surrounding stay pole to be removed

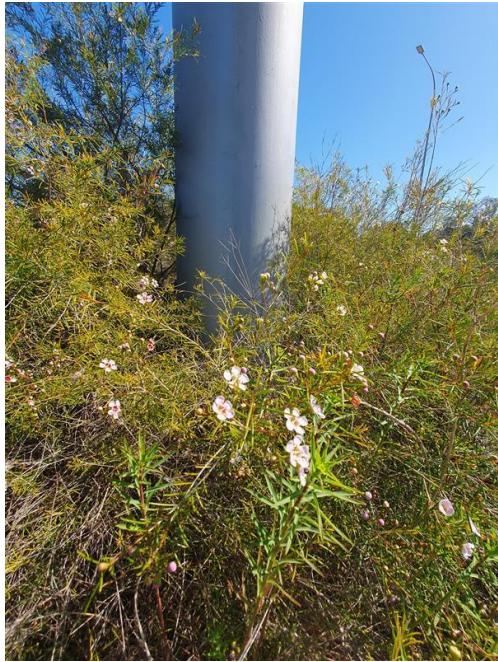
Image 5: Photo of Geraldton wax (*Chamelaucium uncinatum*) surrounding stay pole to be removed

Given the clearing area comprises Geraldton Wax (*Chamelaucium uncinatum*) shrubs with a weed infested understorey, the vegetation in the clearing area is not representative of the above communities. Due to the degraded nature of the clearing area and lack of representative vegetation this project clearing is unlikely to represent any TEC/PECs. Therefore, this project clearing is not likely to impact any TEC/PECs.
