# Vegetation Clearing Assessment Report

Yanchep TX Capacity Reinforcement Works

Western Power Project No.: T0624343/ WSP Project No.: PS218119

November 2025

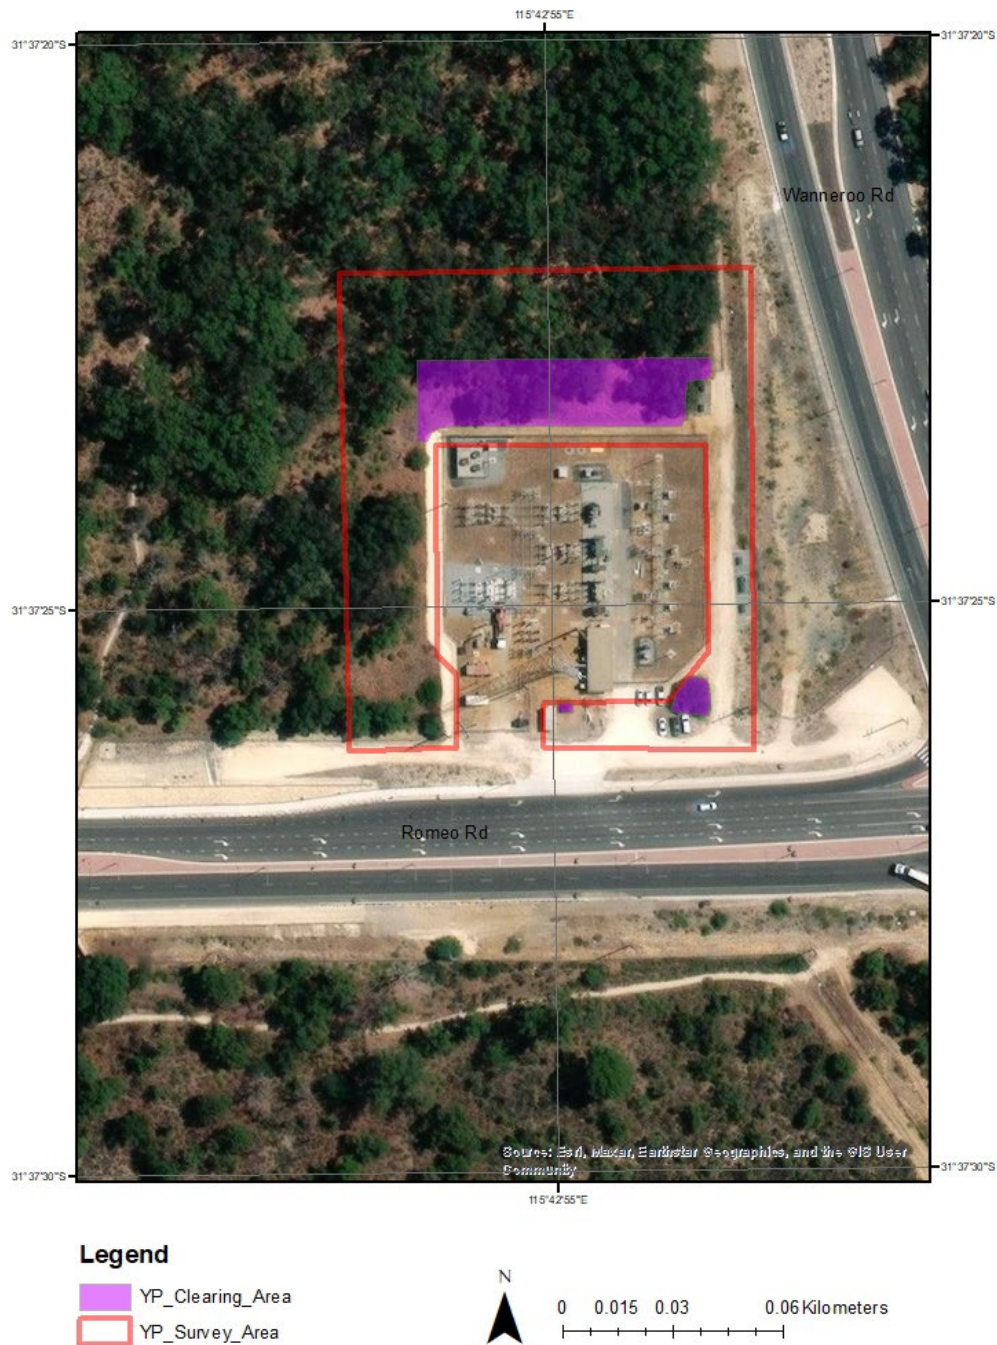
Image 1: Map of proposed clearing area at Yanchep Substation.

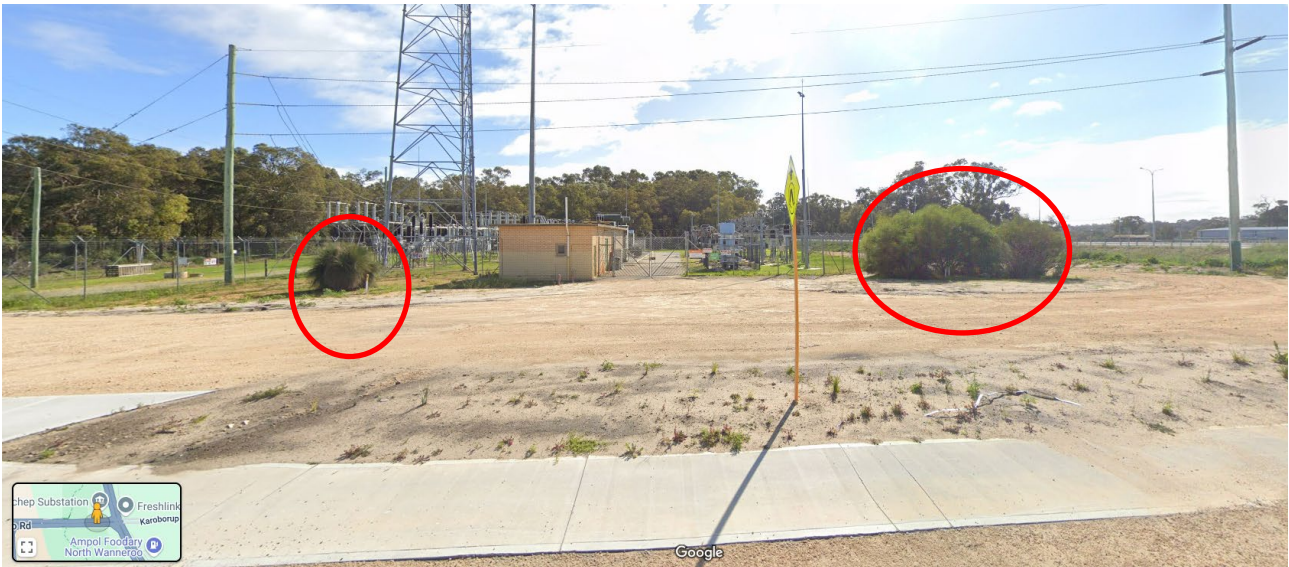
Image 4: Vegetation proposed to be removed at the entrance to Yanchep Substation ([www.google.com/maps](http://www.google.com/maps)).

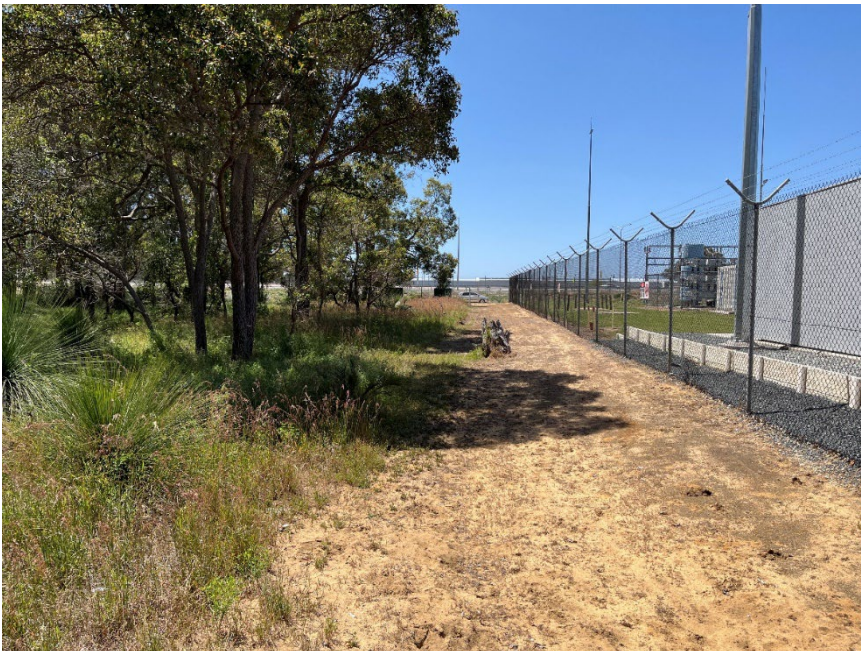
Image 5: Photo of 'good' vegetation proposed to be cleared northwest of substation consisting of a weedy understory.

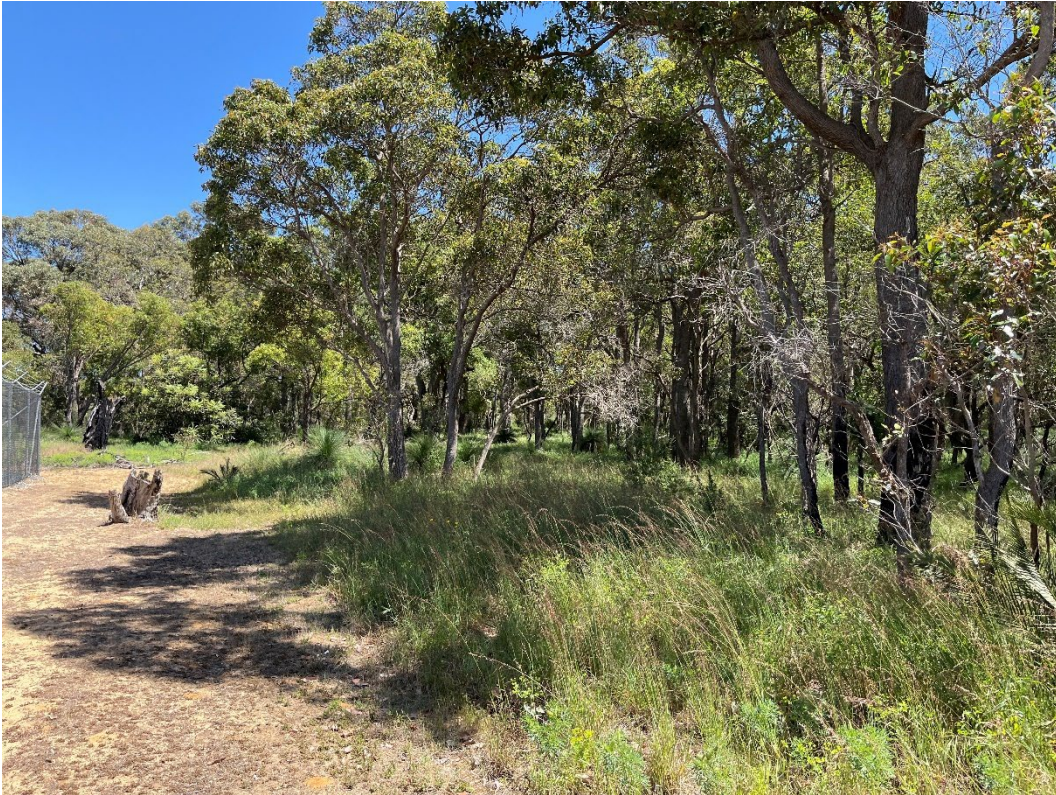
Image 6: Photo of 'good' vegetation proposed to be cleared northeast of substation consisting of a weedy understory
