Vegetation Clearing Assessment Report

Clean Energy Link (CEL) North – Yandin Terminal Bypass

August 2025

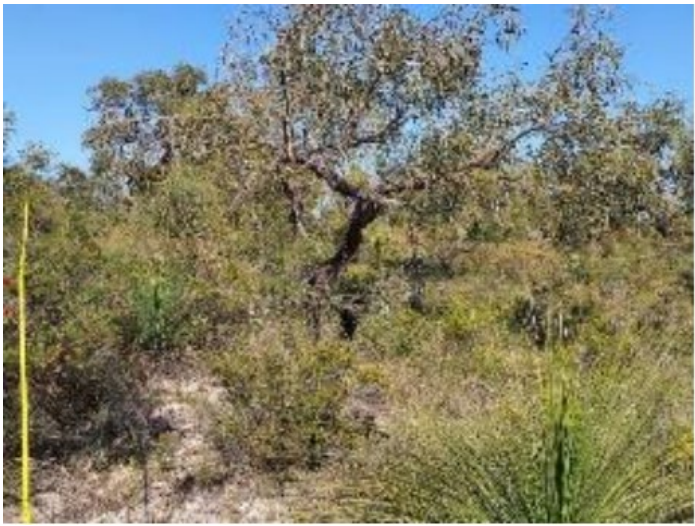
Table 3 Vegetation Community within Proposed Clearing Area

Vegetation Community	Photograph
<p>EtHhPg Banksia Woodland (4.79 ha, 40% of Survey Area)</p> <p><i>Eucalyptus tottiana</i>, <i>Banksia attenuata</i> and <i>Xanthorrhoea preissii</i> low open woodland over <i>Hibbertia hypericoides</i> subsp. <i>hypericoides</i>, <i>Calothamnus quadrifidus</i> subsp. <i>quadrifidus</i> and <i>Allocasuarina humilis</i> mid to low open shrubland over <i>Podotheca gnaphalioides</i>, <i>Dasypogon obliqueifolius</i> and <i>Lyginia barbata</i> low sparse herbland situated on white-grey sandy soils.</p>

Five vegetation communities were mapped within the Survey Area (Figure 2). Banksia Woodland is the sole vegetation community mapped within the Proposed Clearing Area (Table 3) and comprises the entire Proposed Clearing Area (0.68 ha). It was mapped as 'Degraded' due to aggressive weed invasion.

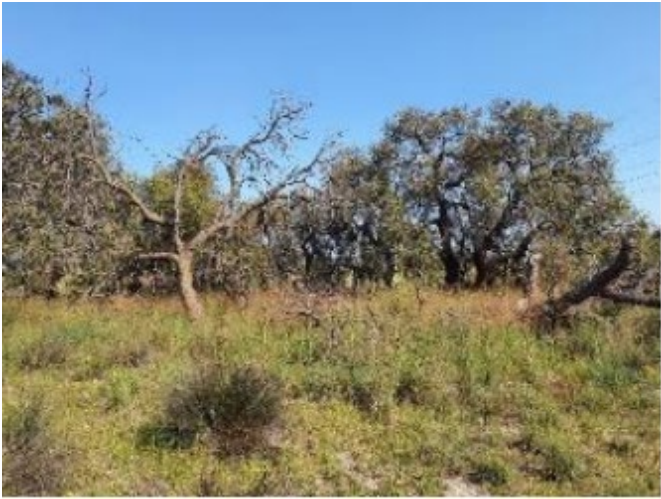
Table 4 Fauna Habitat within Proposed Clearing Area

Description	Photograph
<p>Banksia Woodland dominating over <i>Melaleuca</i> species, with a diverse shrub understorey. Grass species are absent, allowing the structural diversity of the woodland to flourish. Mature <i>Banksia</i> trees, scattered across the landscape. Fine leaf litter and sandy loam soil support the habitat’s plant community. Evidence of recent burns underscores its dynamic nature.</p>

Five fauna habitats were defined and mapped within the Survey Area (Figure 4). Banksia Woodland is the sole fauna habitat mapped (Table 4) within the Proposed Clearing Area and comprises the entire Proposed Clearing Area (0.68 ha). The Banksia Woodland vegetation community is congruous with the fauna habitat of the same name 'Banksia Woodland'.
