Vegetation Clearing Assessment Report

SPS Round 1 Redundant Line Decommissioning – Lake Muir

March 2025

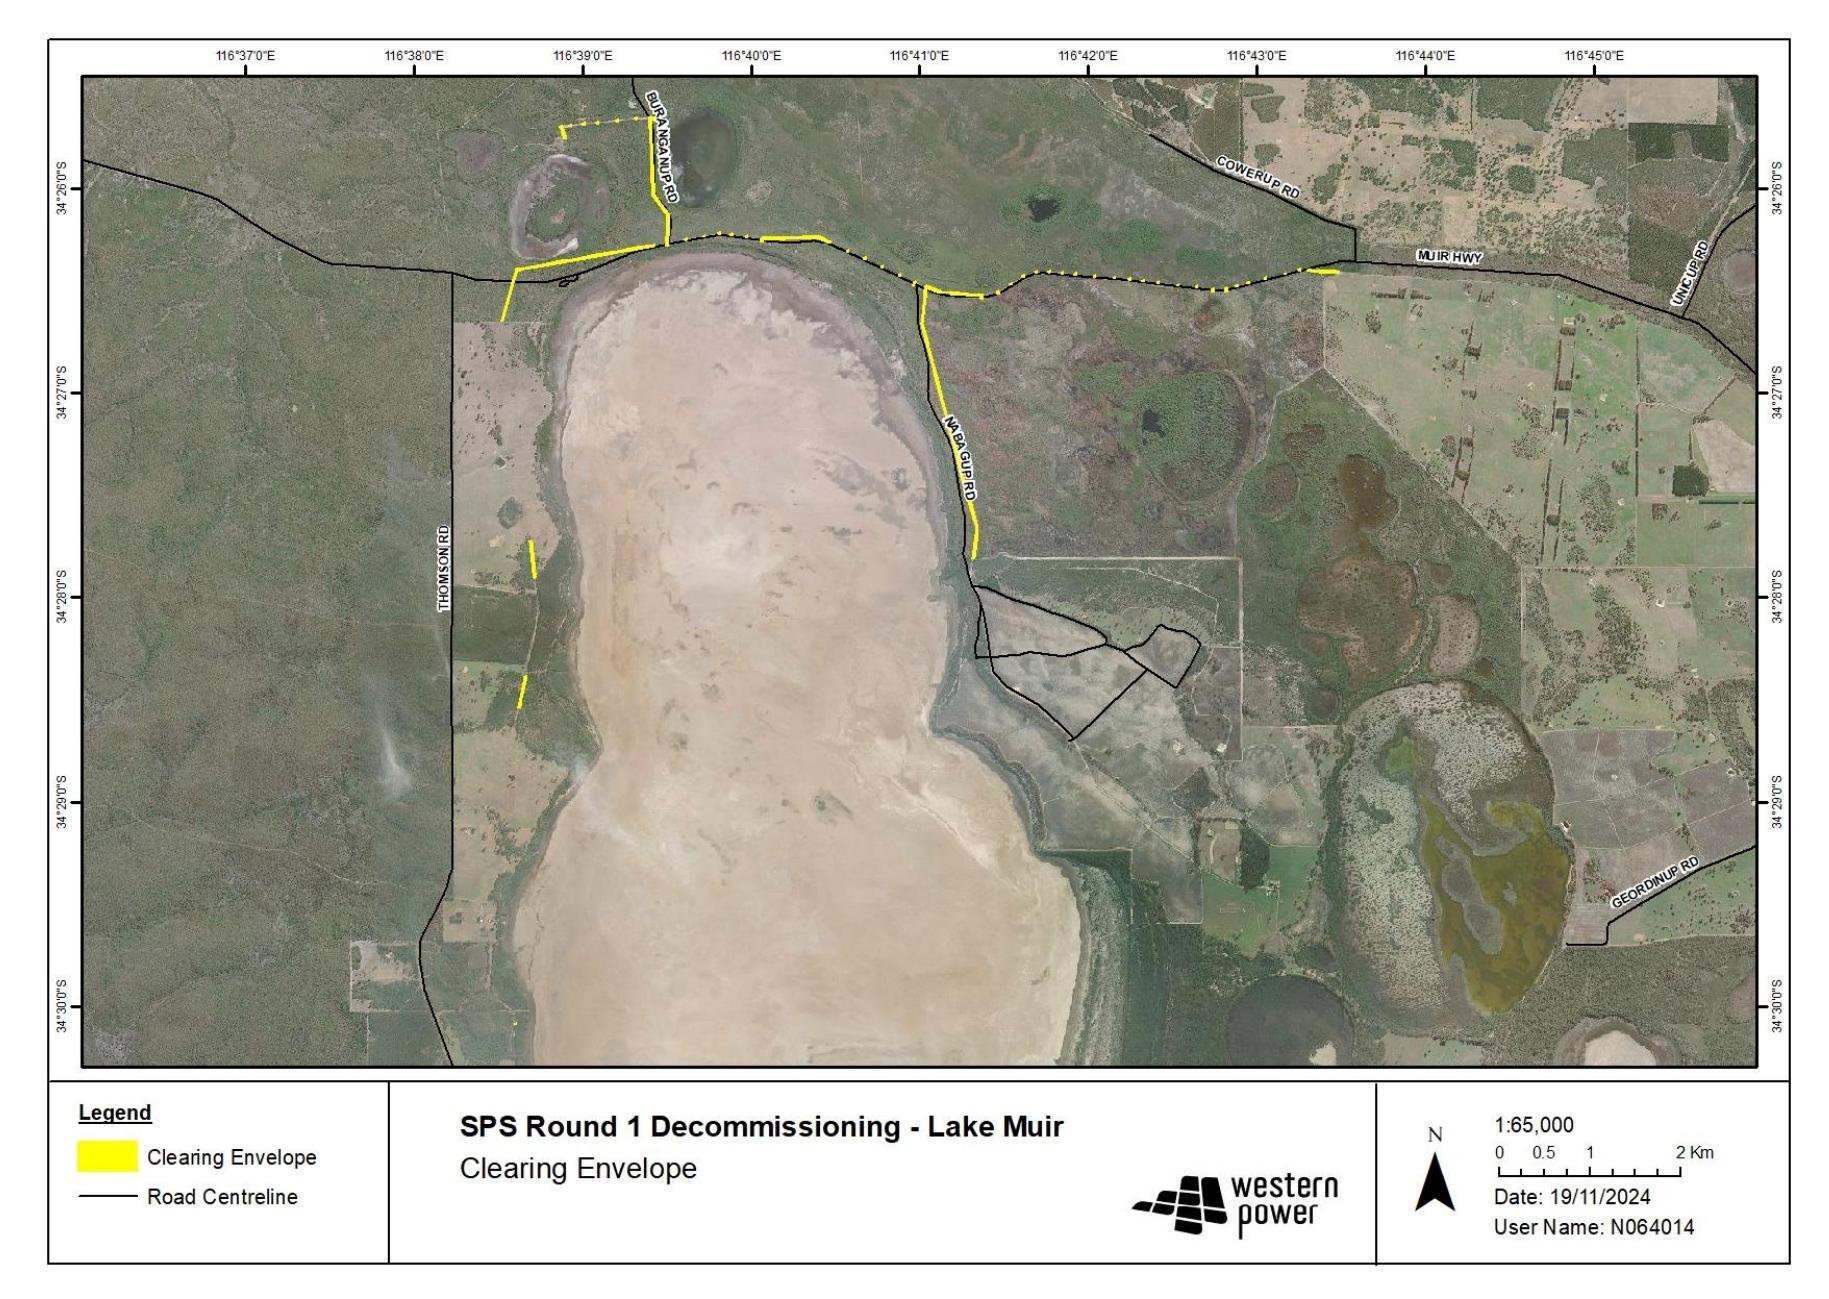
Figure 1 – Clearing Envelope

The proposed clearing will be confined to a clearing envelope of 12.90 ha, which generally corresponds to the maintenance zone. The envelope has been designed to accommodate the winding nature of the existing maintenance access track and any discrepancies between the GPS locations of poles and their actual location on the ground. While the clearing envelope does overlap some remnant native vegetation, the project will only clear previously cleared vegetation within the maintenance zone and as such the remnant native vegetation will not be impacted.

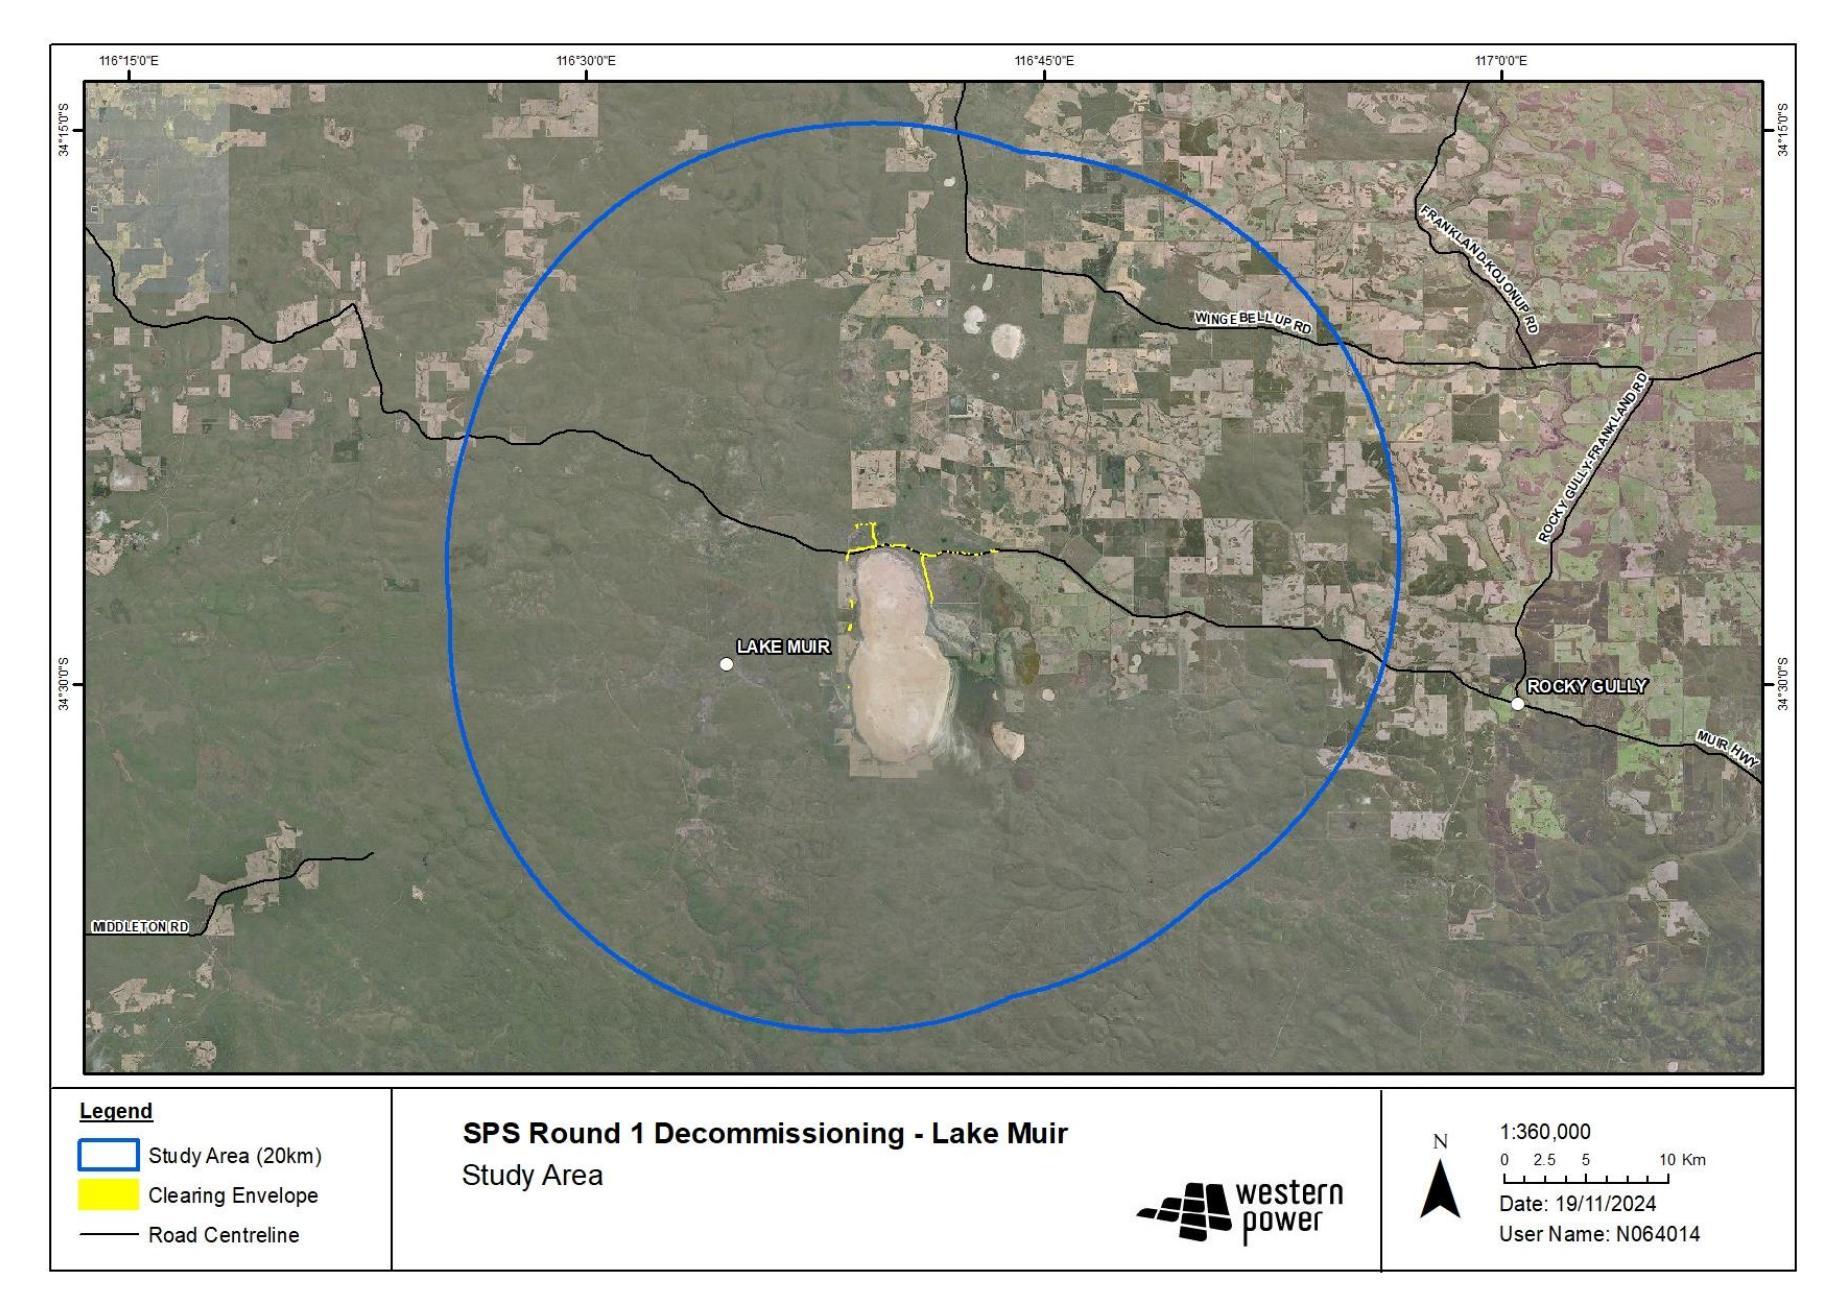
Figure 2 – Study Area

A flora and vegetation assessment was conducted over the clearing envelope and surrounding vegetation in October 2023. The survey area covered a 60 m wide corridor following the line route, representing an 82.6 ha linear corridor. An additional targeted flora survey was conducted in December 2023 during the optimum flowering period for species conservation significant flora.
